## Case Study

# SANDAG Pilot of Conduent® Vehicle Passenger Detection System

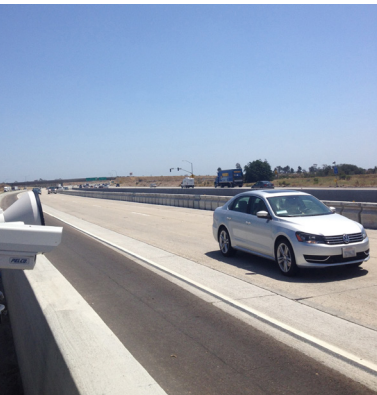
**Figure 1:**  
Side Camera and Illuminator  
(I-15 and Miramar Way)

The system was located on the right shoulder of the northbound HOT lanes on I-15 directly adjacent to an existing toll gantry. VPDS was mounted on the passenger side of the road in the shoulder area. The front camera and front illuminator were mounted on a pole which Conduent Transportation erected and which was aimed at the front windshield. The front camera was approximately 10-12 feet above the road surface. The side camera and side illuminator were mounted at approximately 3.5 feet on a structure that Conduent Transportation had put in place on the roadside.

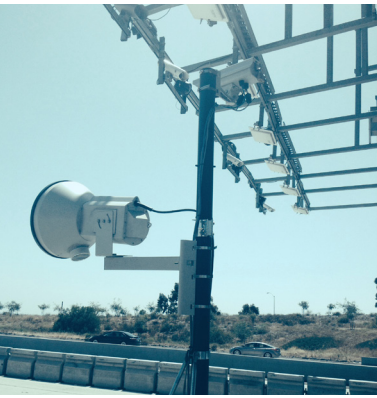
**Figure 2:**  
Front Camera and  
Illuminator (I-15 and  
Miramar Way)

This is a situation that may be encountered in the field, but among the lessons learned is that when mounting on a passenger side location, the front camera should be on a gantry or cantilevered pole to avoid vehicle passenger side "A" pillar obstruction. This is discussed further in the lessons learned portion of the document.
