Case Study

SANDAG Pilot of Conduent[®] Vehicle Passenger Detection System

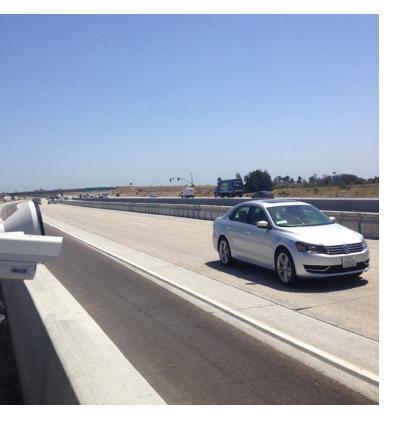
Figure 1: Side Camera and Illuminator (I-15 and Miramar Way)

The system was located on the right shoulder of the northbound HOT lanes on I-15 directly adjacent to an existing toll gantry. VPDS was mounted on the passenger side of the road in the shoulder area. The front camera and front illuminator were mounted on a pole which Conduent Transportation erected and which was aimed at the front windshield. The front camera was approximately 10-12 feet above the road surface. The side camera and side illuminator were mounted at approximately 3.5 feet on a structure that Conduent Transportation had put in place on the roadside.

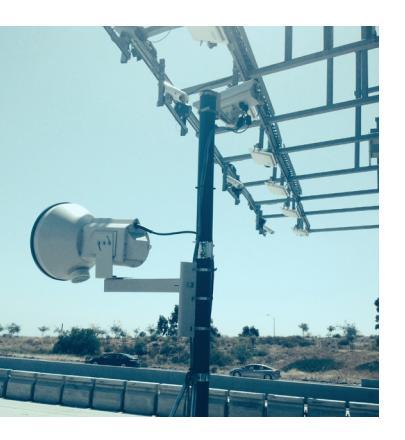
Figure 2: Front Camera and Illuminator (I-15 and Miramar Way) The assessment of the system accuracy performance was developed using data and images collected during the month of June 2015. Note that the system had never seen these images before and

- 1. the system was mounted on a roadside pole and not a gantry, and
- 2. the system was on the passenger side of the vehicle which created some obstructed viewing of front seat passengers due to the vehicle's passenger side "A" pillar partially blocking the view.

This is a situation that may be encountered in the field, but among the lessons learned is that when mounting on a passenger side location, the front camera should be on a gantry or cantilevered pole to avoid vehicle passenger side "A" pillar obstruction. This is discussed further in the lessons learned portion of the document.
